Oxford Brookes University - Historic Building Analysis and Recording (HCON7004)  
(University of Oxford – Unit 3 Post-Graduate Certificate in Architectural History)

Bond's Mill Gatehouse  
Stonehouse, Gloucestershire GL10

Julia Tu  
May 2023

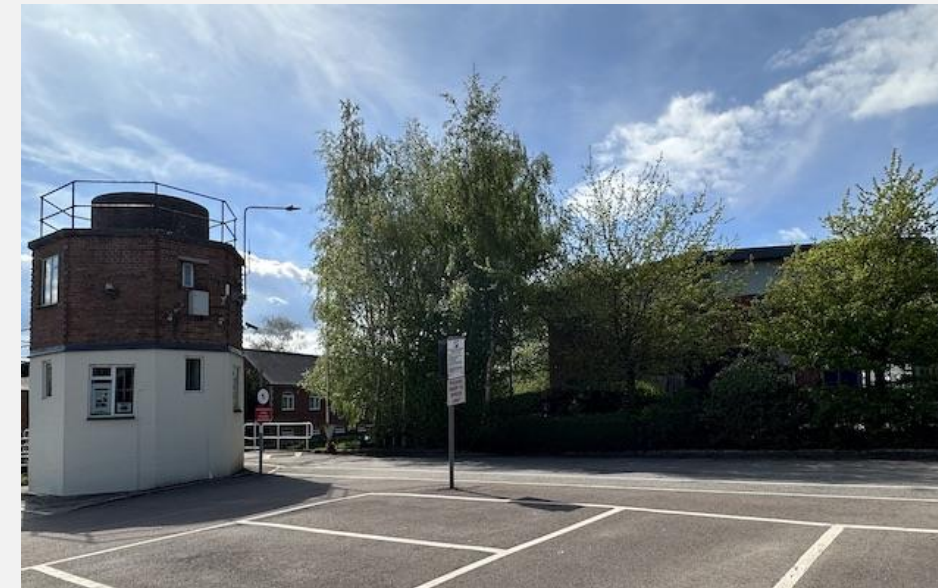
Figure 3: Bond's Mill Gatehouse location between two industrial areas

The gatehouse is situated between two light industrial areas with a car park separating it from a main road and a further industrial estate (see Figures 3 and 4 right). To the south of the canal lies Bond's Mill (not a listed building), today home to a number of small businesses.

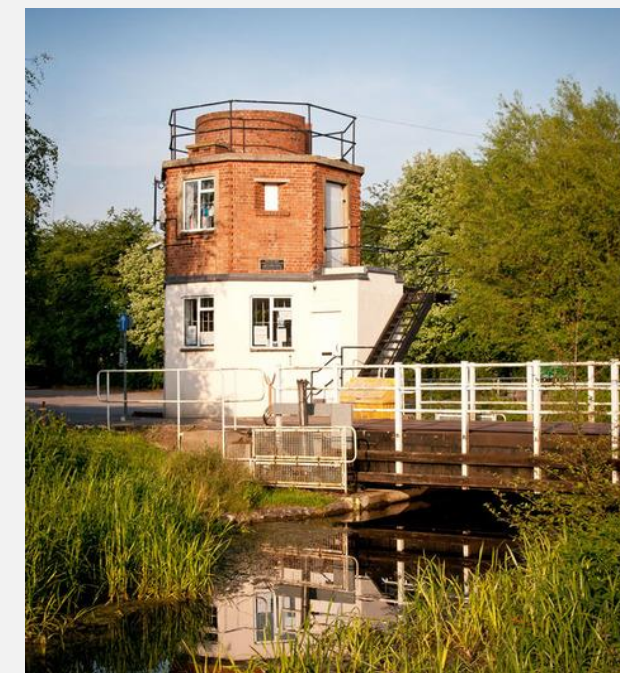
Figure 4: Bond's Mill Gatehouse canal-side location

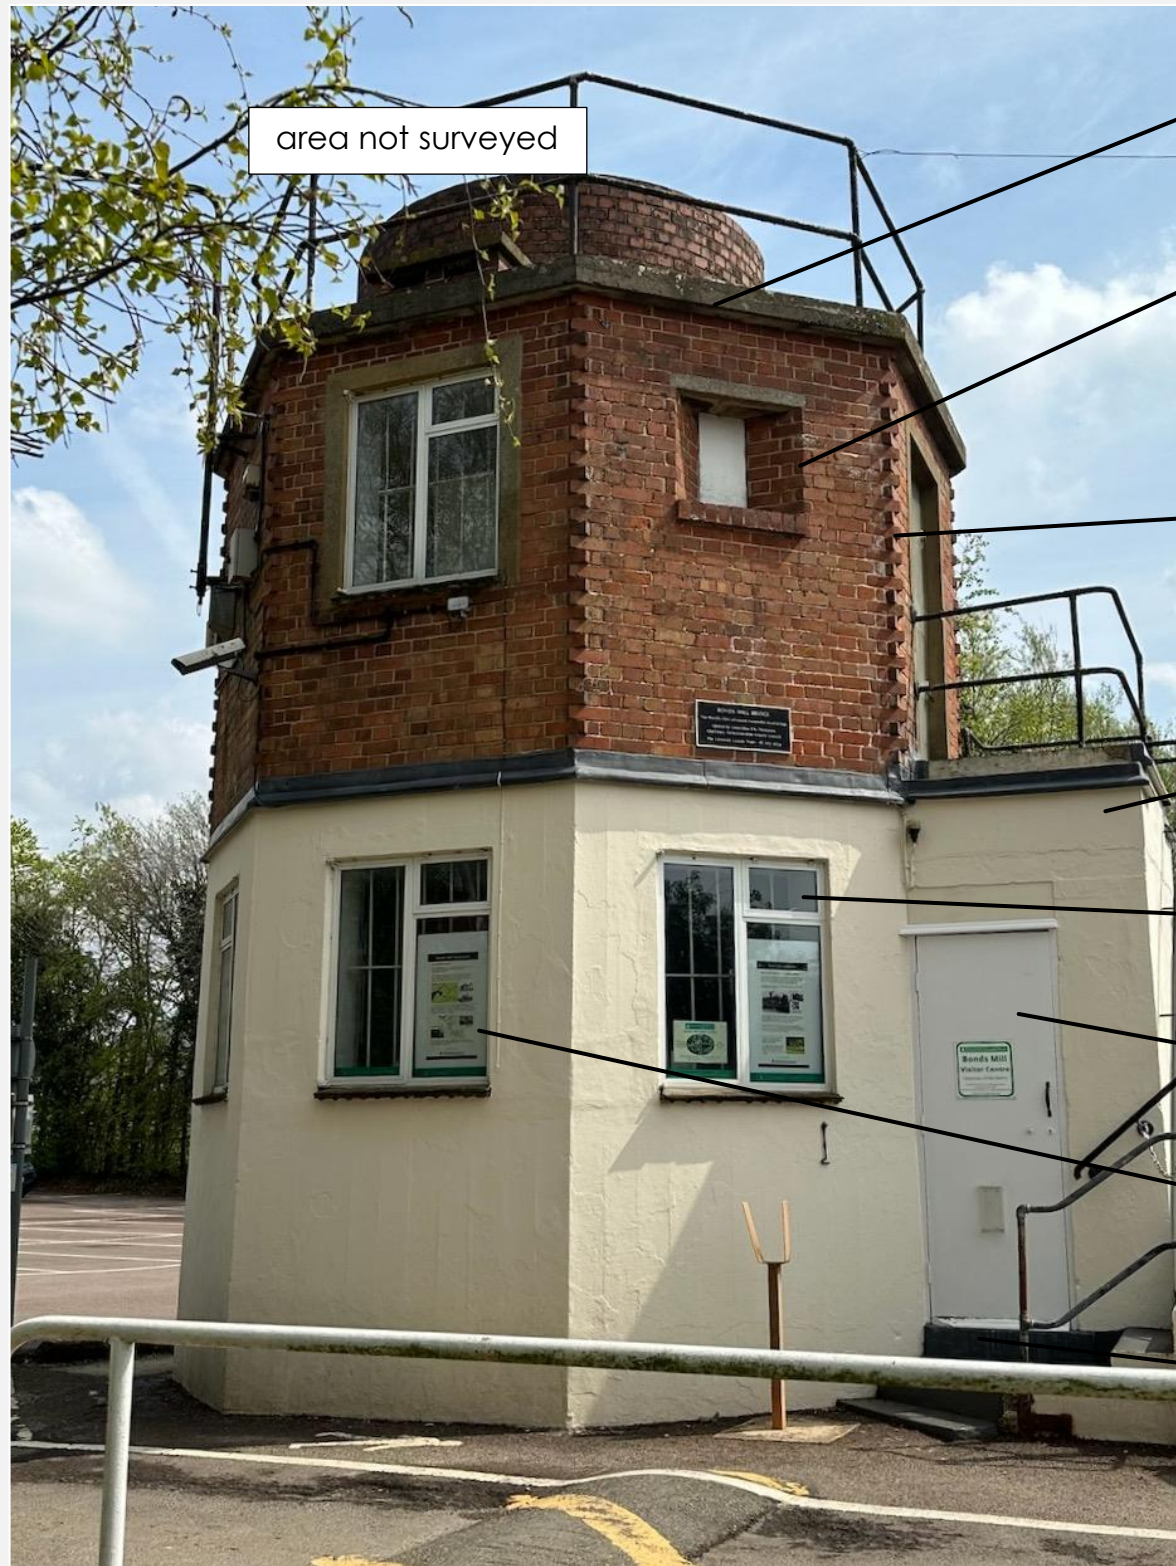
## Northern Elevations

Non-original opening with concrete architrave

Original embrasure with concrete lintel now single-glazed though obscured

Bricks finished in a cogged style at corners

Porch height has been increased to aid addition of external steps

Originally a horizontal embrasure, larger opening made before 1970s and clay tile cill added

Replacement door

Non-original opening cut out between 1940s and 1970s (and clay tile cill added).

Non-original steps

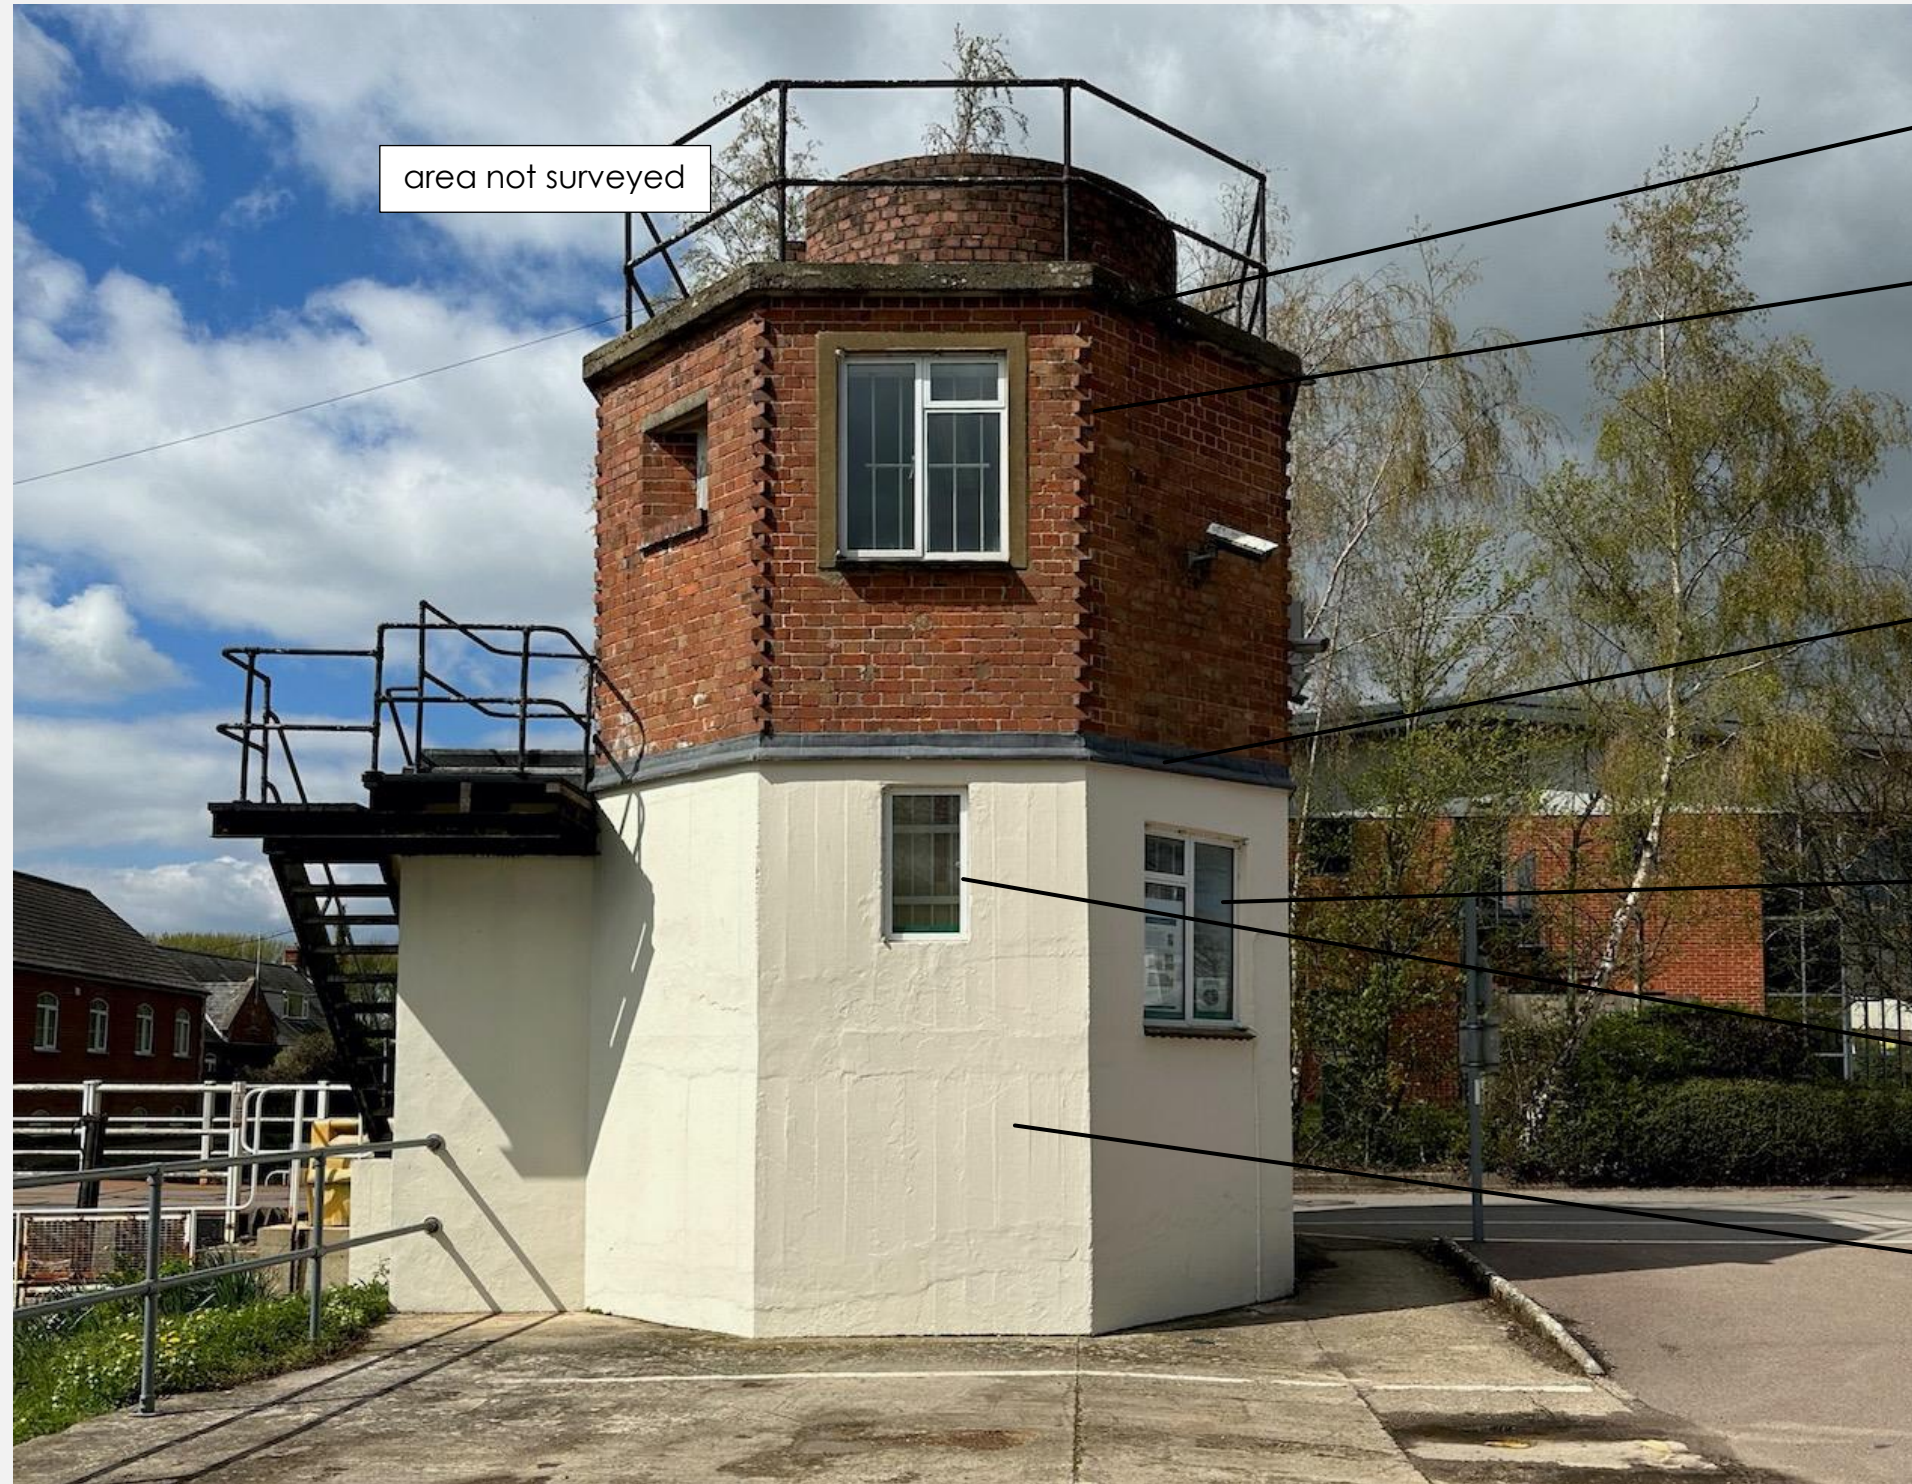
## Southern Elevations

Prefabricated concrete roof/ceiling to upper floor

Non-original opening cut out between 1940s and 1970s with concrete architrave

Post-1994 apron flashing

Non-original opening cut out between 1940s and 1970s with clay tile cill added

Original embrasure, probably not glazed originally

Evidence of construction method (prefabricated shuttered concrete panels)

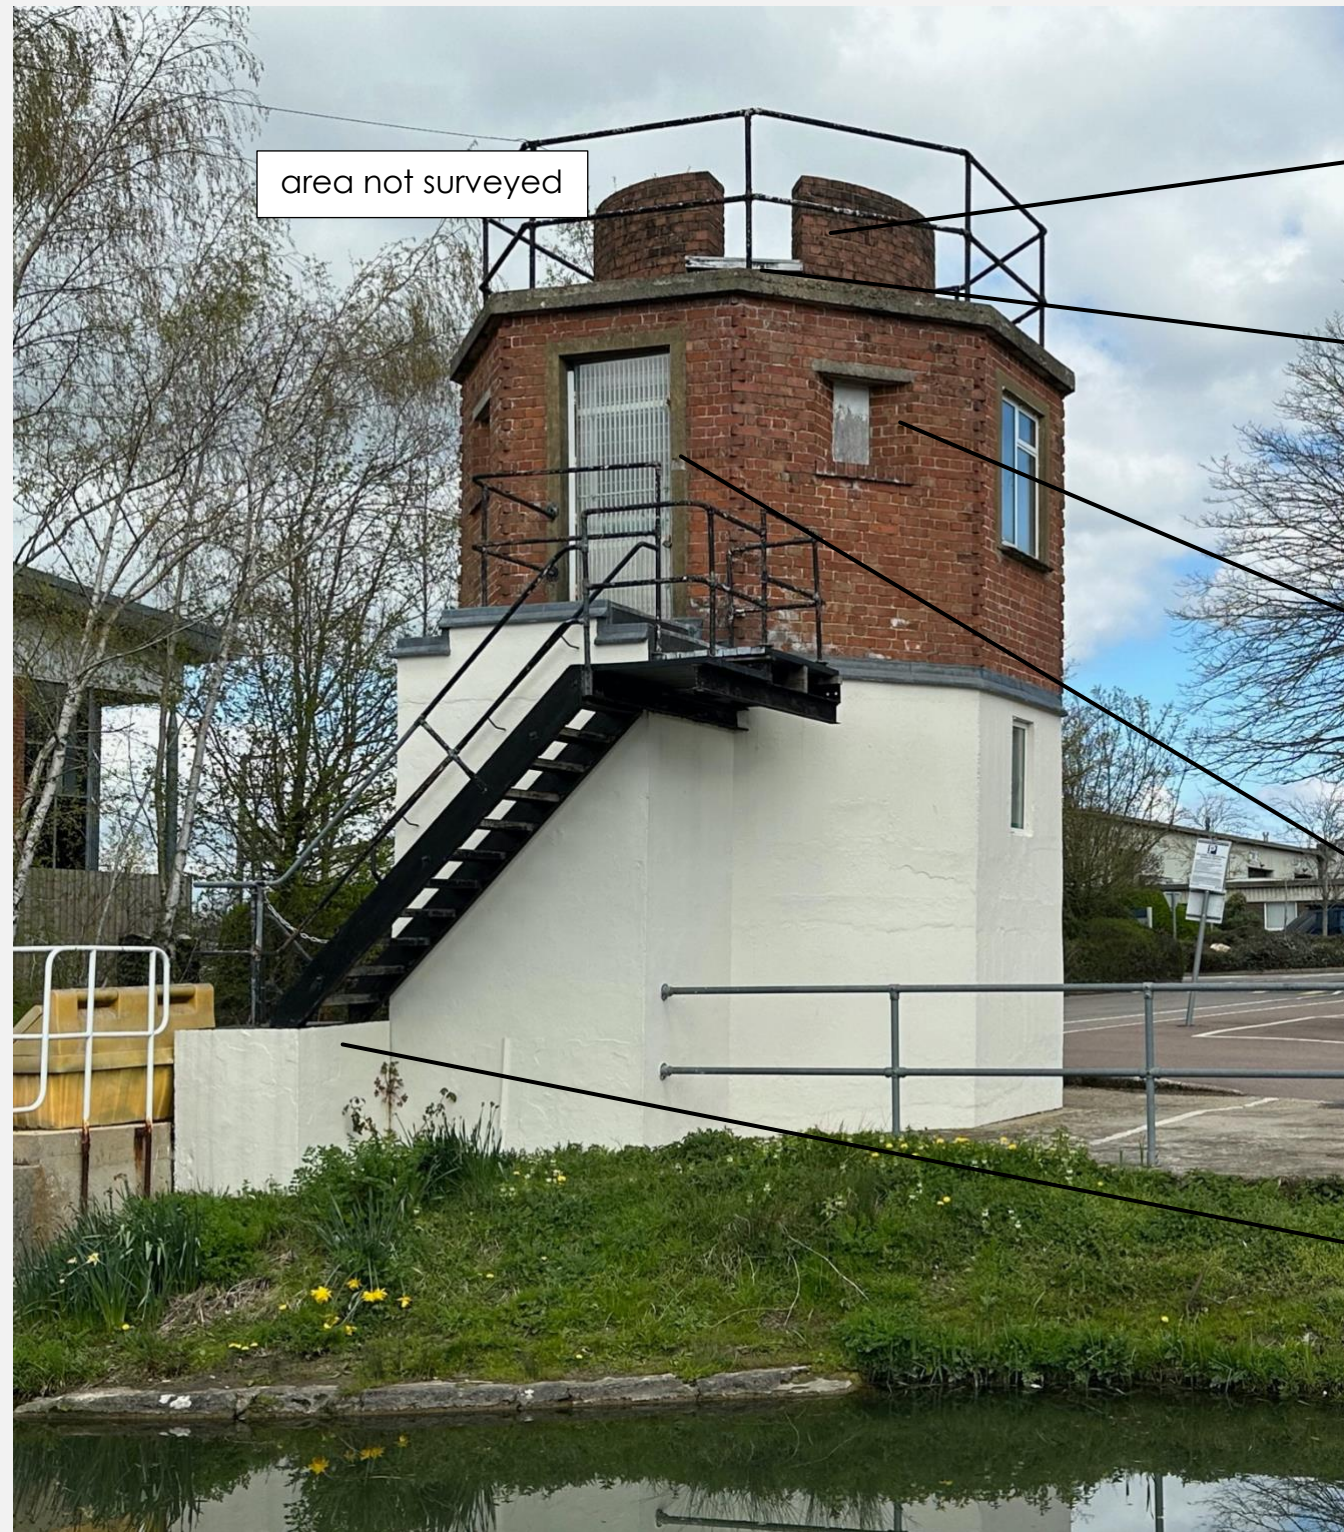
## Western Elevations

Machine gun emplacement on turret

Roof hatch reached internally by fixed ladder

Original embrasure, glazed but obscured

Non-original doorway with concrete architrave added to upper floor elevation removing need for internal ladder between ground and upper level

Concrete steps at north elevation also provide support for wooden steps to upper floor level (not original)

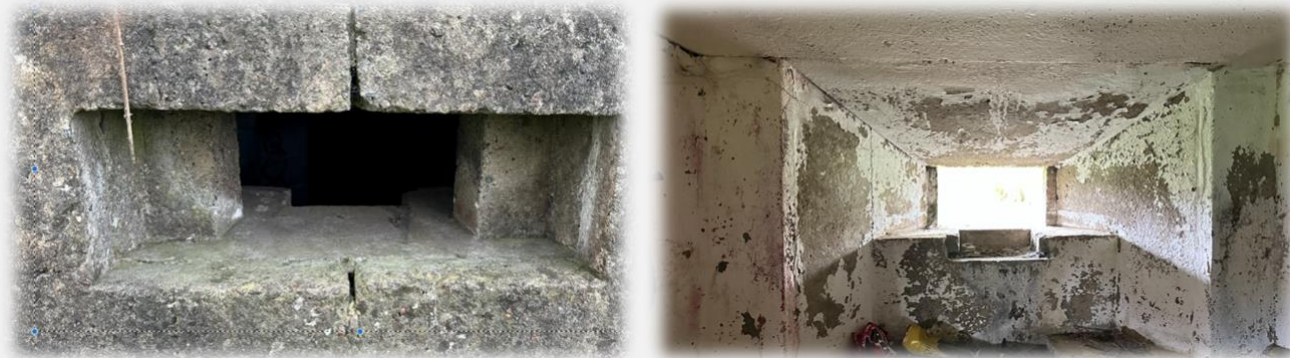
**Features 1 and 7:** Prefabricated embrasures are likely to resemble of the unaltered pillbox to the south of Bond's Mill (see Figures 11 and 12 below):

Figure 11 and Figure 12: External and internal views of an embrasure

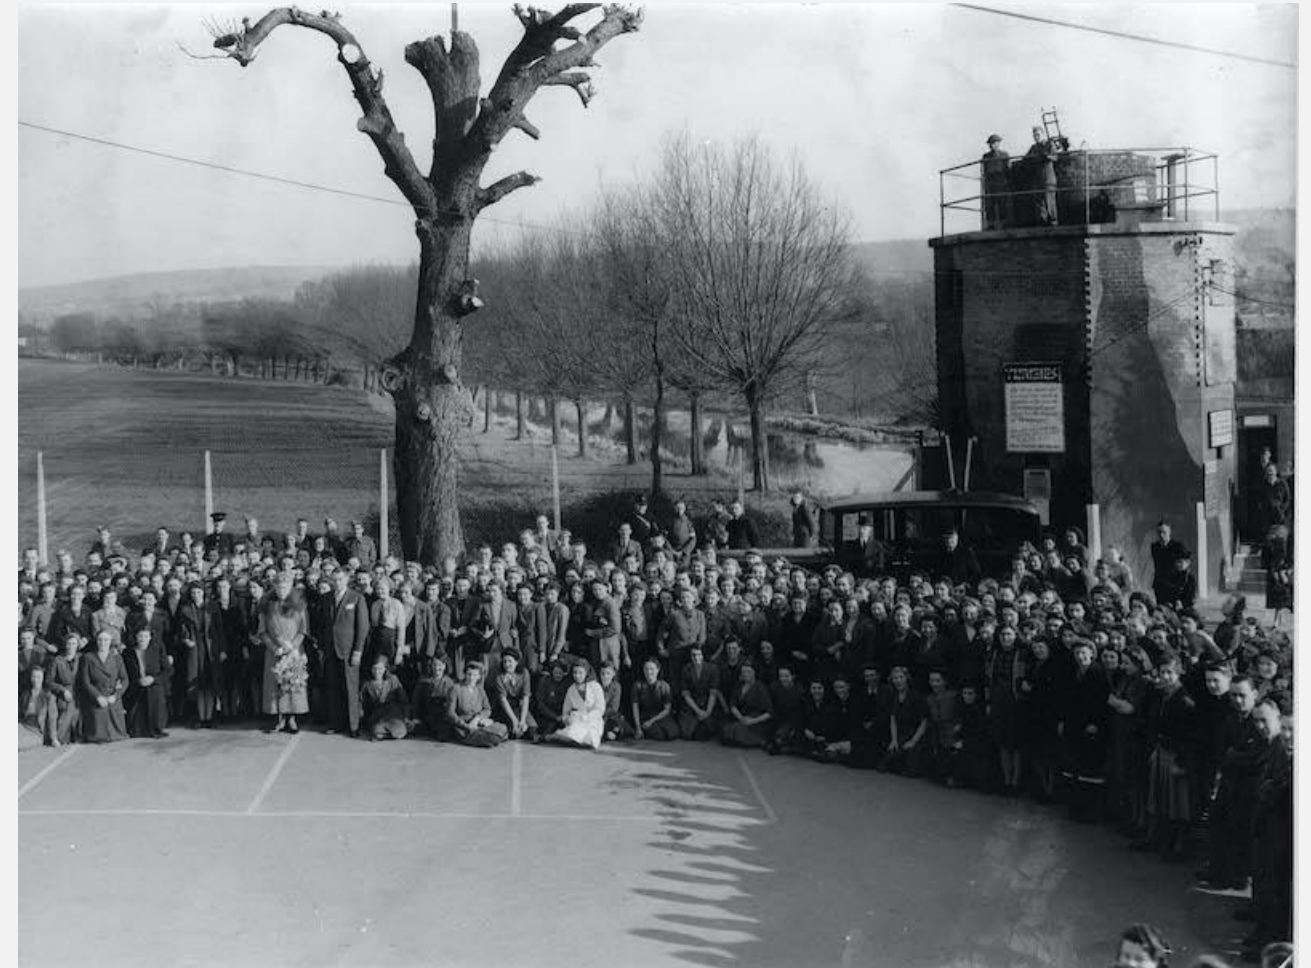
Figure 13: Visit of Queen Mary's Visit in spring 1941 © The Peckham Collection, c/o Stonehouse History Group

Both figures show a portion of Queen Mary's visit to Bond's Mill pillbox in 1941 (see Figure 13) but Figure 9 does not contain the door area and makes some features clearer

Figure 9 above identifies a brick wall around the southern elevation of the pillbox and evidence of repairs to the entrance porch, southern and eastern elevations was identified during the photographic survey. The Historic England listing and Defence of Britain<sup>6</sup> archive document possible indications of a blast wall to the door however none is visible in the 1940 photograph (see Figure 10 above).

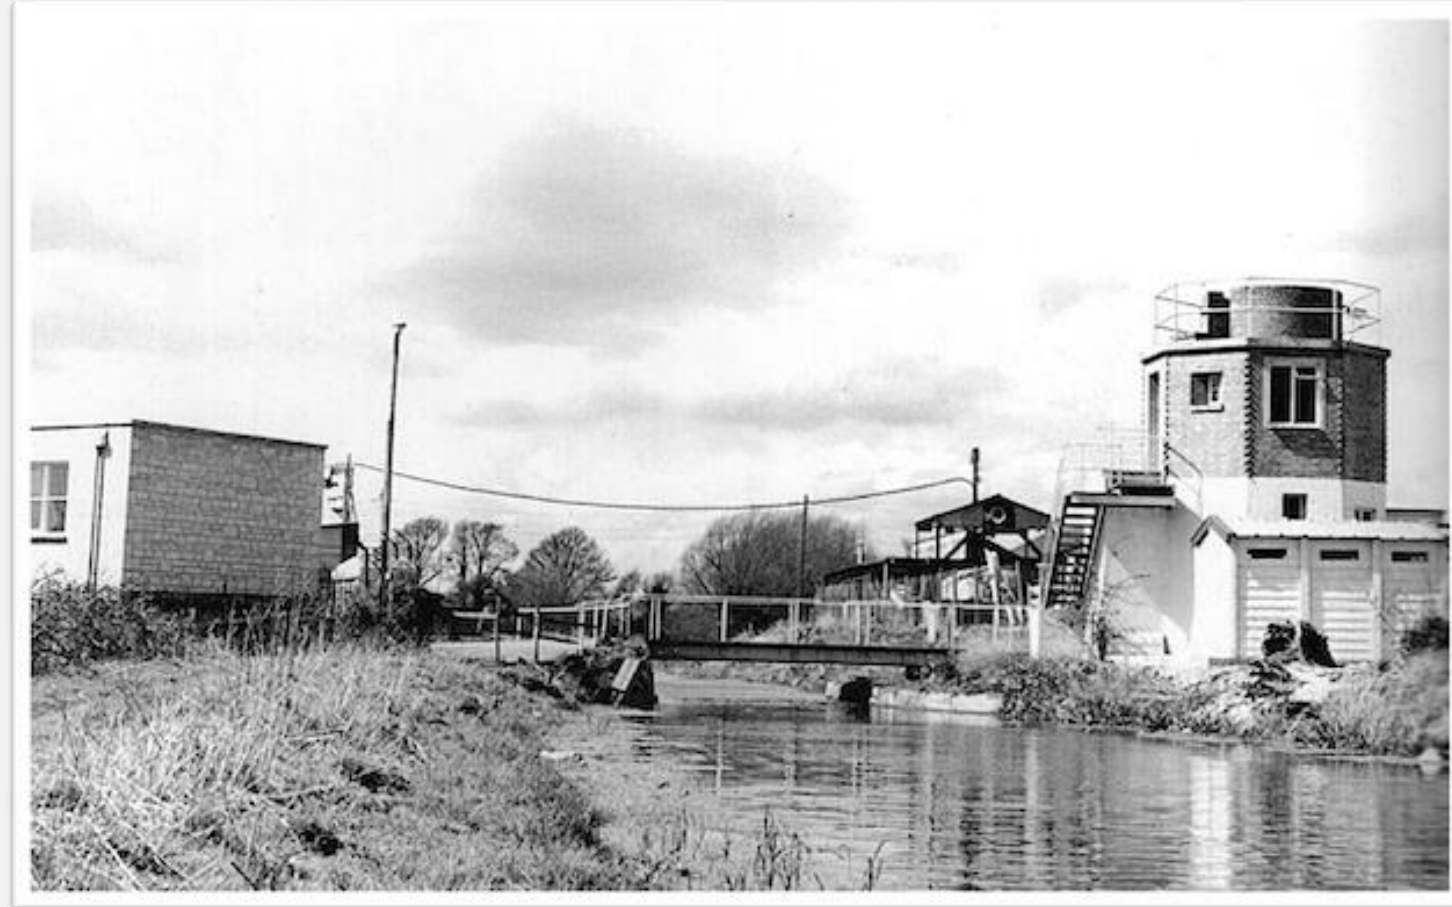
Figure 14: 1970s photo showing the swing bridge and pillbox © M. Handford

This picture identifies that, between the end of the war and the 1970s, the following had already taken place:

- at upper floor level, the larger window openings seen today had already been made either in elevations that previously had no embrasure (those with a concrete architrave)
- the height of the entrance porch has been raised and concrete block inserted at ground level to support the new steps
- the steel stairway with timber steps had been added, thereby removing the need for the internal ladder between floors
- also at upper floor level, a doorway had been inserted, also with a concrete architrave
- at ground floor level, the horizontal embrasures had been enlarged and new large openings created.
- Crittal-style window frames had been installed

- the ground floor of the building (constructed of concrete) had been painted white.
- any blast protection to the south of the building had been removed
- any camouflaging has been removed
- it's probable that the clay tiled cills at ground level were added to larger openings in this period

These changes are believed to have been made to facilitate reuse as commercial space.

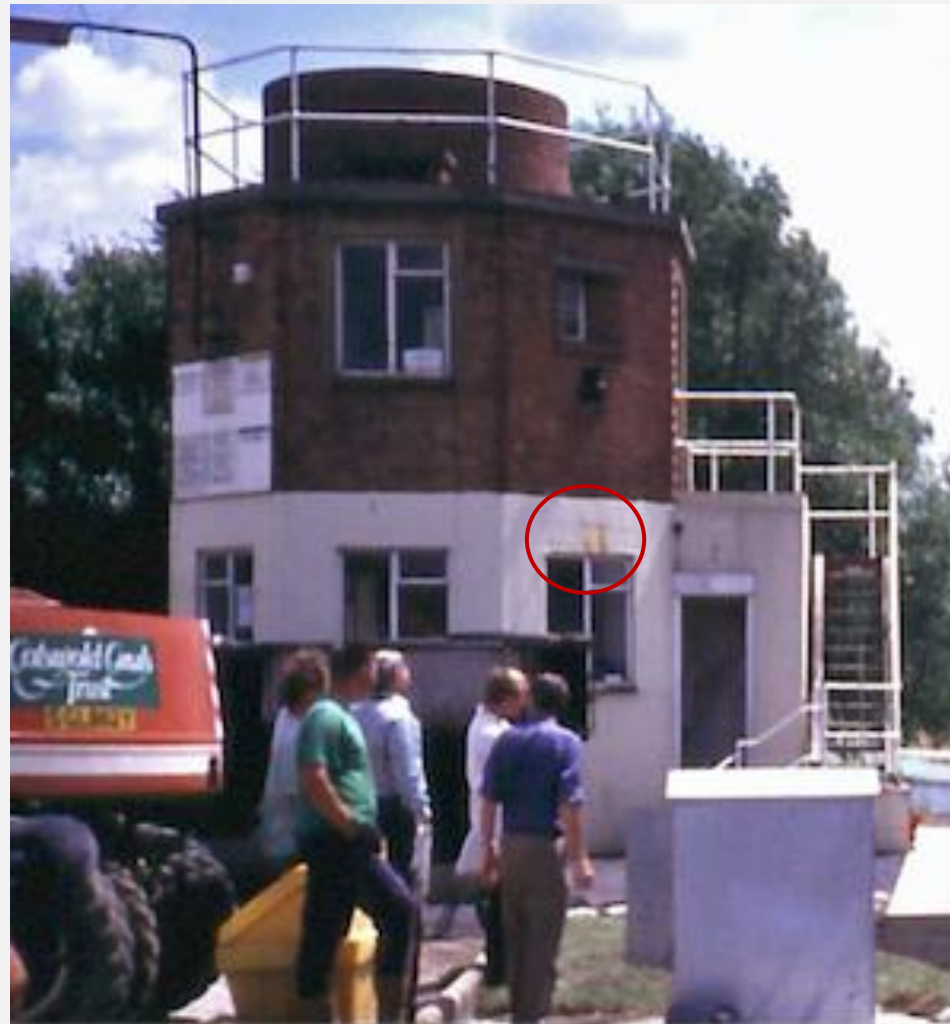
Figure 15: Photo known to be from May 1994 with no lead flashing and evidence of rust staining circled  
© Stonehouse History Group

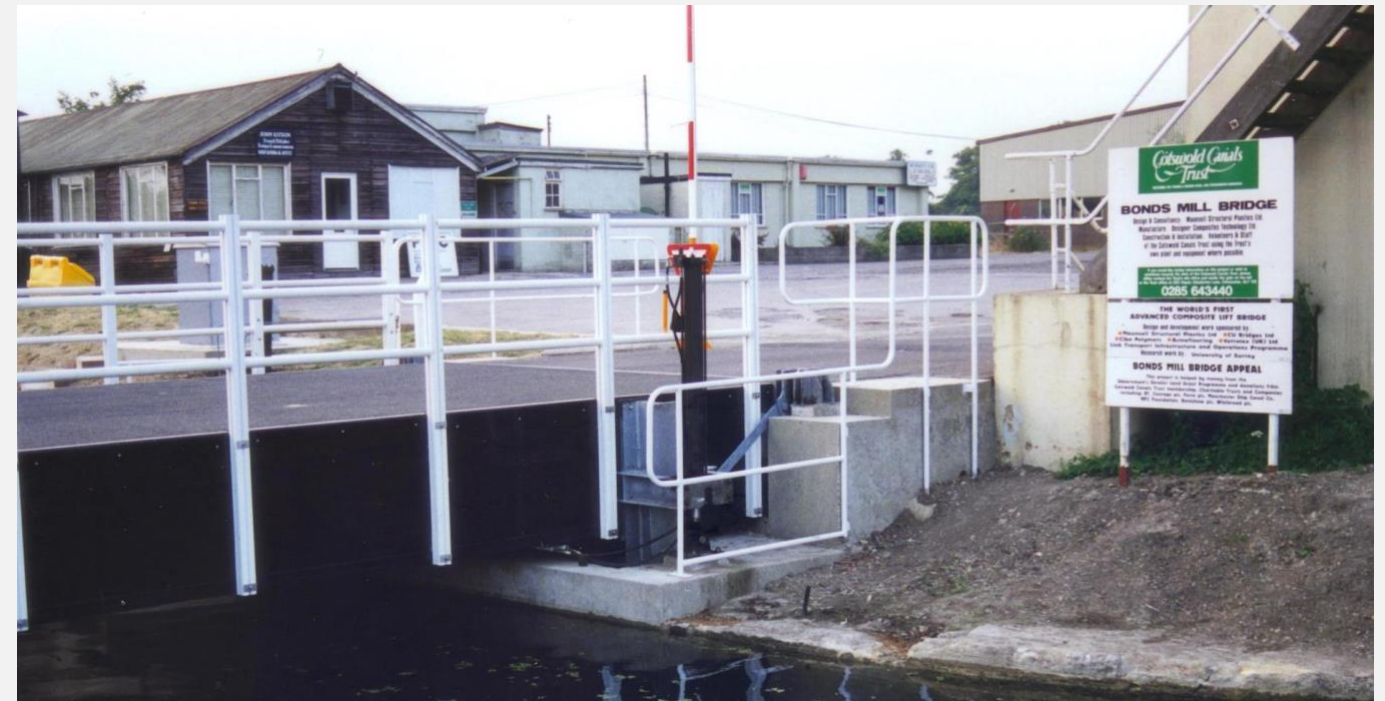
Figure 16: 2015 South-western perspective site changes © Stonehouse History Group

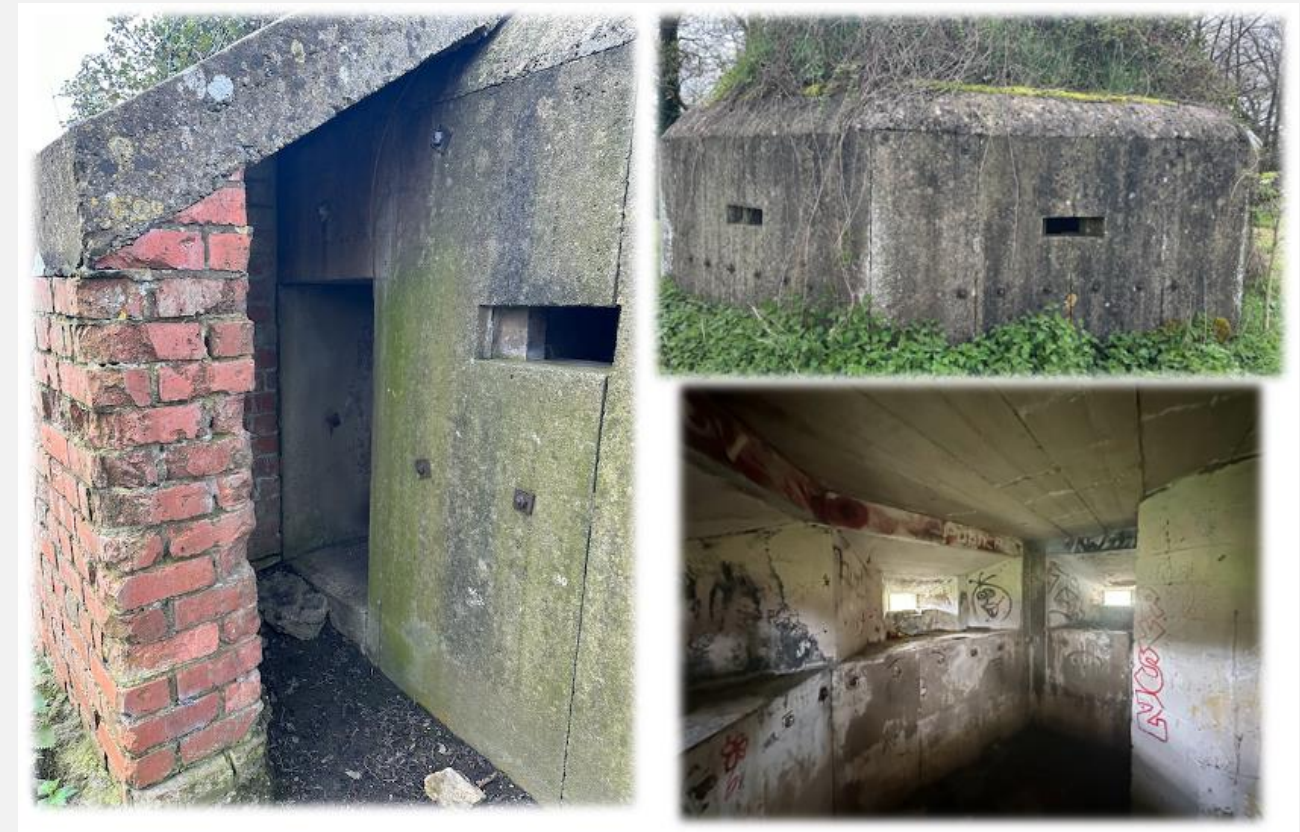
Figure 27: The reinforcements seen at the pillbox south of Bond's Mill which include reinforced entrance porch, iron bolt reinforcement to thicker walls along with a ricochet wall

**Feature 2:** Pillboxes in this area were protected with a brick-built protective porch (see Figure 27) with a reinforced roof. This is a local variation not found along other defence lines.<sup>4</sup> Embrasures afforded limited visibility and an observer was generally placed outside the building to obtain a better view.<sup>5</sup>
